Smallest Issue Matters

By Betsy Gott
Rx Monitoring Services, Inc.

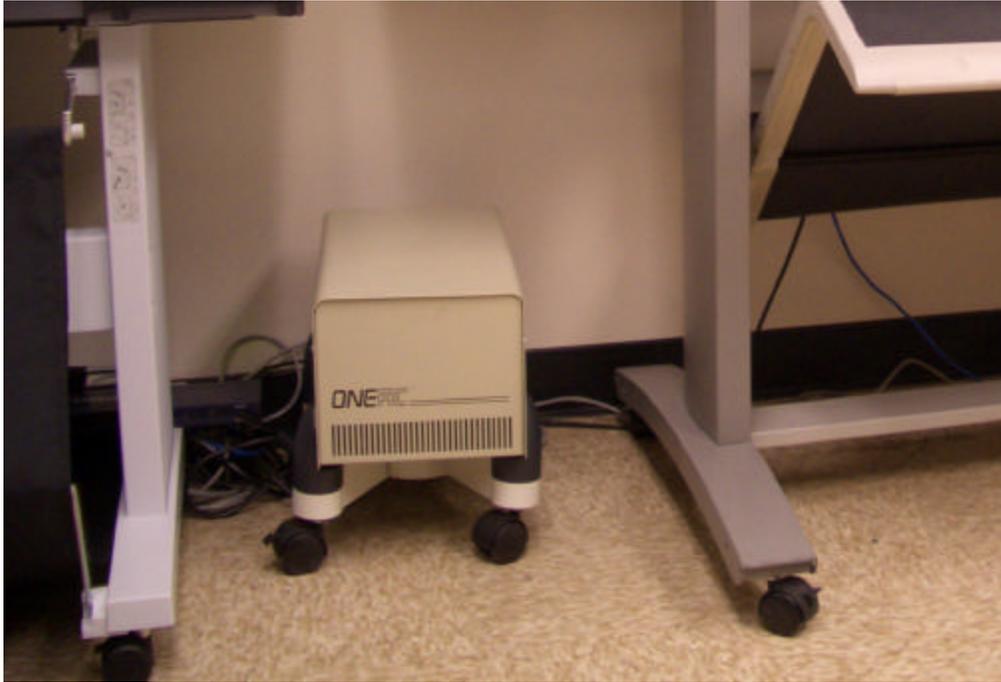
One of ONEAC's UPS's that was placed in Franco's site to help correct the issues with his equipment.

The Power Quality Report showed that there was nothing wrong with the power at Franco's site and everything met the equipment's specs. The report did show that the temperature in the room where the Trendsetter is located was extremely high at 98° Fahrenheit, where the preferred temperature would be 72° Fahrenheit. Since the room temperature was found not to be the issue leading to the double images, one would be puzzled as to what the issue was that was causing this disorder. After looking into further details of the report, the engineers at RxMS found that the Trendsetter had severe Power Factor Correction (PFC) impulses, which were most likely due to the utility switching on and off of the PFC capacitors. While switching on the PFC capacitors can actually save customers thousands of dollars on their electric bill, there is one short eight millisecond waveform that occurs. These events caused sophisticated electronic fits, as there were multiple zero-crossings and over-voltages that degrade and cause false turn-on of the equipment. Seeing as how their system was resetting, it could eventually cause component damage, which would cost them time and money in the future if it was not tended to. Motor sensors skips were also found, which were due to the PFC impulses and sags. RxMS recommended that Franco add an on-line, double conversion type Uninterruptible Power Supply (UPS) to totally protect their system.

solution was achieved since over sizing would have cost Freedom money and wasted energy. The report was handed over to Gene Wasserberg, a representative for Gryphon, Inc. Wasserberg reviewed the report and its necessities and then consulted with ONEAC Corporation of Libertyville, IL. ONEAC is a leading international manufacturer of power conditioners and Uninterruptible Power Supplies. They decided that a 7kVA Synergy UPS would be the best solution for Freedom. This 7kVA Synergy UPS is a double conversion technology and can easily supply the high inrush of the system by filtering out the low frequency PFC waveform. Since the surge protections cannot clamp low enough and line interactive UPS turn-on too slow after the distortion occurs, the ONEAC Synergy is precisely the best solution for Freedom. This Synergy UPS saved Freedom time and money and since the unit is typically smaller than the other technologies, it allowed Freedom to place the unit under the plate loader, taking up no additional floor space. The double conversion technology that this specific Synergy UPS consists of is required to filter out this relatively new event of PFC impulses. Until RxMS's patented monitoring technology, this event has been very difficult to document. When dealing with typically only 20 volts in amplitude, the event does not easily show up as an impulse in view of the fact that most power monitor's thresholds are typically set at a much higher level. The distortion level is sub-cycle, typically only 4-6 milliseconds long, and therefore rarely trips the sag event trigger in most monitoring system. If it does trip, then the event log is usually so long that it is easy to miss since there are so many events. Finding the event with this unique distortion is difficult and time consuming. "Not only is RxMS unbiased, which is great, but the expertise they bring to Kodak's customers is invaluable," stated Jim Rivest, Zone Service Manager for Kodak.
